RECOGNIZING DEFECTS IN CARBON-FIBER
REINFORCED PLASTICS

R. Schuetze and W. Hillger

Translation of "Erkennbarkeit von Fehlern in CFK-Laminaten",
Deutsche Gesellschaft fuer Luft- und Raumfahrt, Jahrestagung,
Aachen, West Germany, DGLR Paper 81-057, May 11-14, 1981, pp 1-20

1. Report No. NASA TM-76947	2. Government Accession No.	3. Recipient's Catalog No.	
4. Title and Subtitle RECOGNIZING DEFECTS IN CARBON-FIBER REINFORCED PLASTICS		5. Report Date September 1982

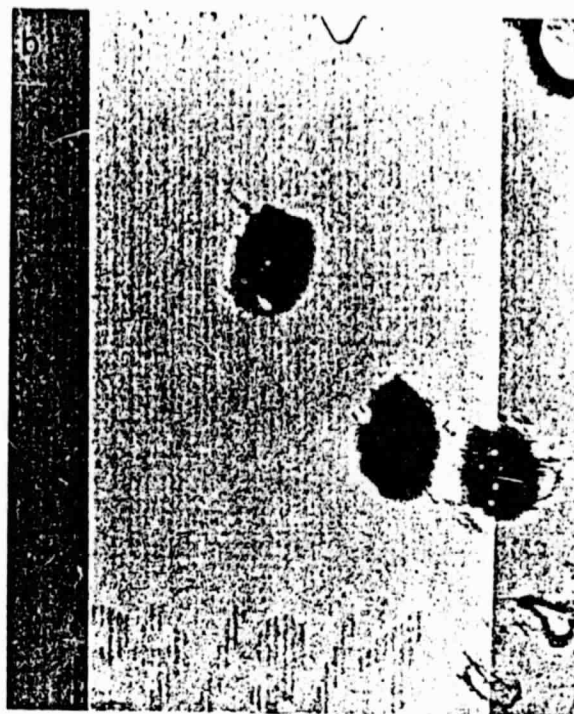
Figure 6. C-scan, X-ray picture and evaluation of the destructive test of
the sample 24/9/1.

Laminate 24/9/1

Laminate thickness : 1,5 mm

a) US-C-scan: 10 MHz
focus test head

b) X-ray picture of the contrasting
sample

c) Evaluation of the destructive
test

In contrast to sample 73/1/1, the C-scan of sample 24/9/1 (Figure 6) shows three relatively clearly outlined defects whose sizes were also confirmed to a large extent by the other test methods. The defects (lenticular-shaped cavities) could be easily found by means of US-testing and it was shown that the determination of the defect edges depended less on the setting of the sensitivity of the US-apparatus than for sample 73/1/1.

The fact that the defect edges were not blurred by pores is also shown by the X-ray picture of the contrasting sample. The three clearly visible delaminations (bubbles) could not readily be confirmed in the TBE-immersion bath since there were no connections to the cutting edges through which the contrast agent might have been able to penetrate. Therefore, the bubbles were drilled in accordance with the previously made US-C-scan and were contrasted individually under a vacuum bell jar.

After X-ray testing, sample 24/9/1 was cut into 45 0.2 mm thick slices whose cross-sections were measured under the microscope. The result is shown in Figure 6.

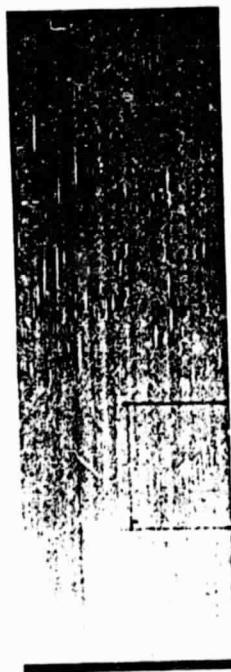
Figure 7. C-scan and x-ray picture of the sample 1465 A.

Laminate 1465A Laminate thickness : 3.2mm Test frequency : 10 MHz
X-ray energy : 15 keV Illumination time : 30 s

Figure 7 shows C-scan and X-ray picture of the sample 1465A. The 3.2 mm thick laminate contains voids of different sizes and position. The sometimes very voluminous voids can be easily recognized in the X-ray picture even without contrasting. X-ray picture section and C-scan exhibit the same sample area and are shown to the same scale. A comparison of both representations shows how accurately even very small voids can be depicted with the aid of the high-resolution US testing system.
